G310S REPLACEMENT BACKLIGHT ASSEMBLIES

DETERMINING BACKLIGHT REPLACEMENT KIT

G310S BACKLIGHT REPLACEMENT PROCEDURE - G3BR10S1

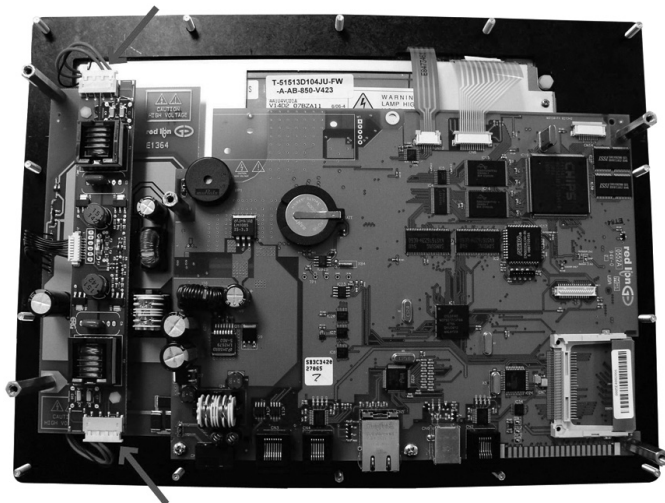
OPTREX CCFL BACKLIGHT (Two Backlights, Three Wires Each)

For customers with an original Optrex display that uses two CCFL backlights, part number G3BR10S1 is used to convert the existing display to use the new LED backlight assemblies. This kit contains two backlight assemblies and a board that drives these new LED assemblies.

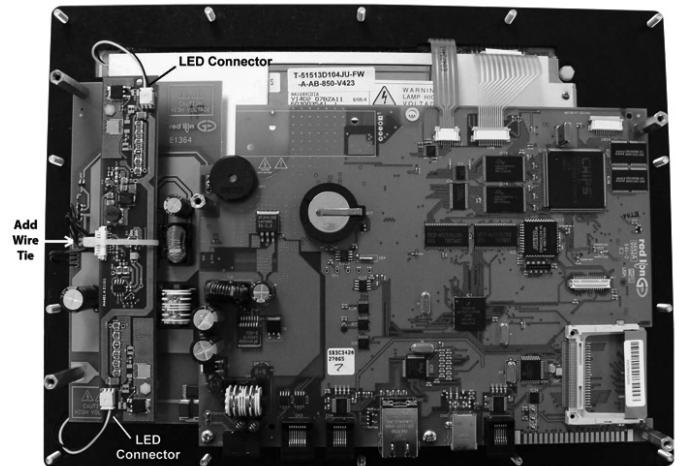
OPTREX LED BACKLIGHT (Two Backlights, Two Wires Each)

For customers with an Optrex display that has already been converted to use LED backlights (two backlights), part number G3BR10S2 is used for replacement backlight assemblies only.

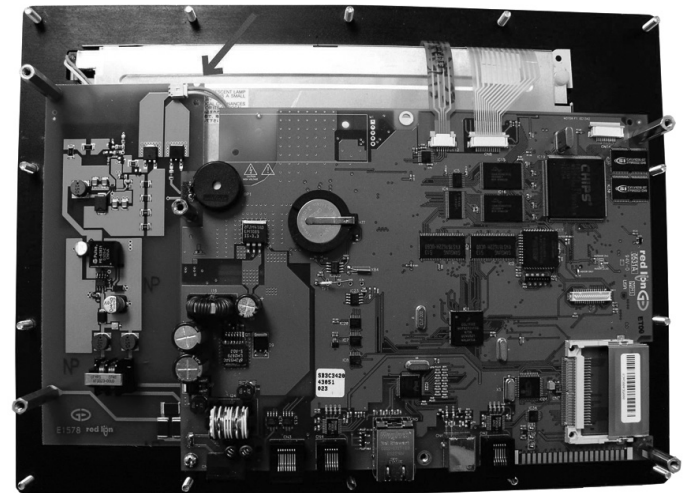
NEC LED BACKLIGHT (One Backlight)

For customers with the newer NEC display, this backlight is not field replaceable. This unit must be returned to Red Lion Controls for repair.

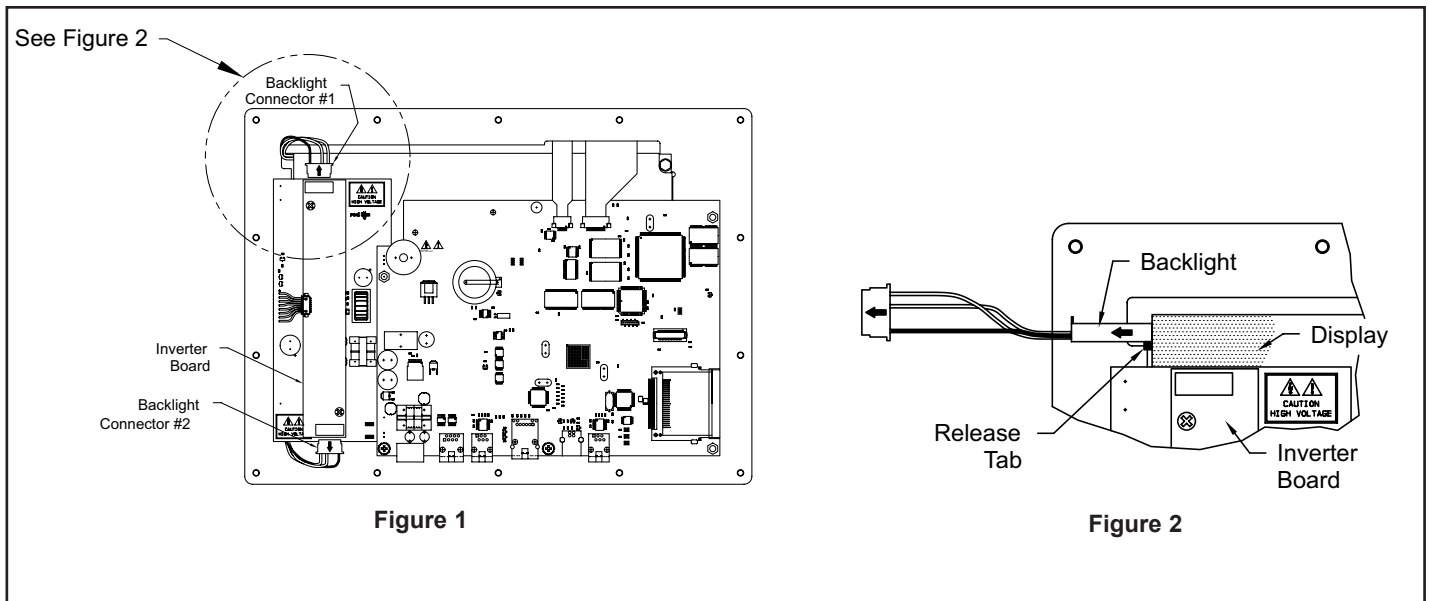
1. Remove the power and PLC Communications connectors from the unit.
2. Remove the five screws from the rear cover.
3. To replace the inverter board with the LED driver board, carefully remove heat shrink tubing (if present) from the backlight connectors on the inverter board (refer to Figure 1).
4. Remove the backlight connectors from their connector housings on the inverter board.
5. Disconnect the 8-position cable from the inverter.
6. Carefully remove the two nylon screws holding the inverter in place.
7. Replace the inverter with the new LED driver board.
8. Reinstall the 8-position cable into the new LED driver board.

10. To replace the backlight assemblies, depress the backlight release tab and carefully remove the backlight as indicated in Figure 2. Repeat for the other backlight.

1. Remove the power and PLC Communications connectors from the unit.
2. Remove the five screws from the rear cover.
3. Remove the backlight connectors from their connector housings on the inverter board.
4. To replace the backlight assemblies, depress the backlight release tab and carefully remove the backlight as indicated in Figure 2. Repeat for the other backlight.
